Eagle House
25 Memorial Drive
Lunenburg, MA 01462

Property Condition Assessment

February 23, 2018

VERTEX Project No: 48237

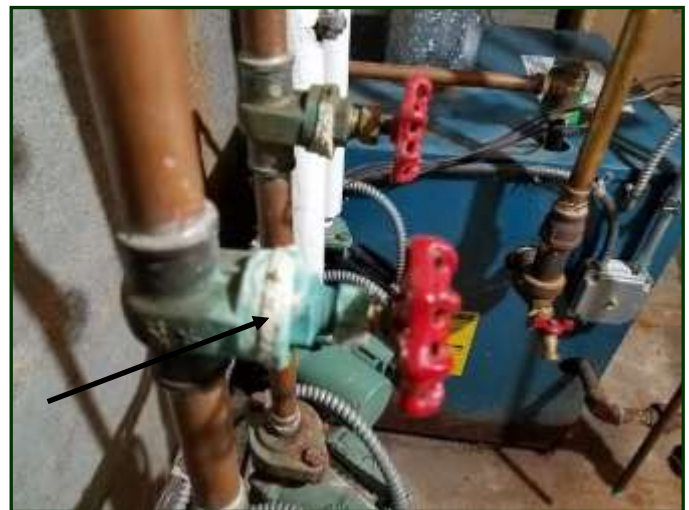
Photo #100: Missing insulation on hot water piping
